WINDOW LIFT MOTOR AND REGULATOR REPLACEMENT PROCEDURE

1992-1996 TOYOTA CAMRY 2 DOOR

88316 / WLA1286 & 88317 / WLA1398 CAMRY FRONT MOTOR & REGULATOR

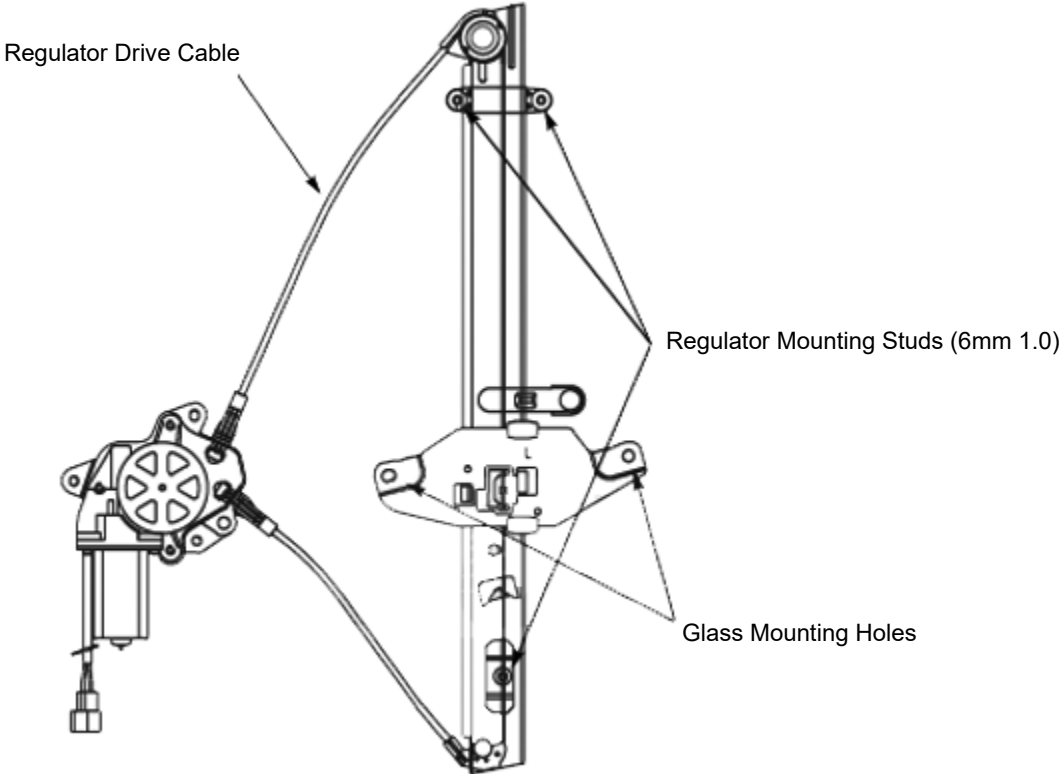
View - 88316 / WLA1286 Left Front Facing Door from Outside Car

Check to make sure the glass channels are clean and free from obstructions. All regulator mounting attaching hardware requires a 10mm socket or wrench. The regulator needs to be in position to remove glass mounting bolts (see drawings on opposite side). If the motor has stopped where the glass attaching bolts are not accessible, cut one of the regulator drive cables with a suitable tool. This will allow movement of the glass so glass mounting bolts are accessible. Secure glass and remove glass mounting bolts then the regulator and motor mounting nuts. Slide motor and regulator through opening in door.

Insert new motor and regulator into the door while making sure the glass is still in the closed position. Loosely fasten regulator to door beginning with mounting holes by the motor and then loosely fasten the regulator nuts. The glass mounting holes on the replacement motor and regulator should be in position for access through the door. Slide down glass and fasten to regulator. Tighten down all nuts. Attach window lift wiring to switch on unattached trim and test operation. Reconnect remaining wiring and affix trim to door.
